**WEAR DEBRIS ANALYSIS OF GREASE  
LUBRICATED BALL BEARINGS**

Advanced Technology Office  
Support Equipment Engineering Department  
Naval Air Engineering Center  
Lakehurst, New Jersey 08733

12 APRIL 1982

Final Report  
AIRTASK A3400000/0518/1F53537401

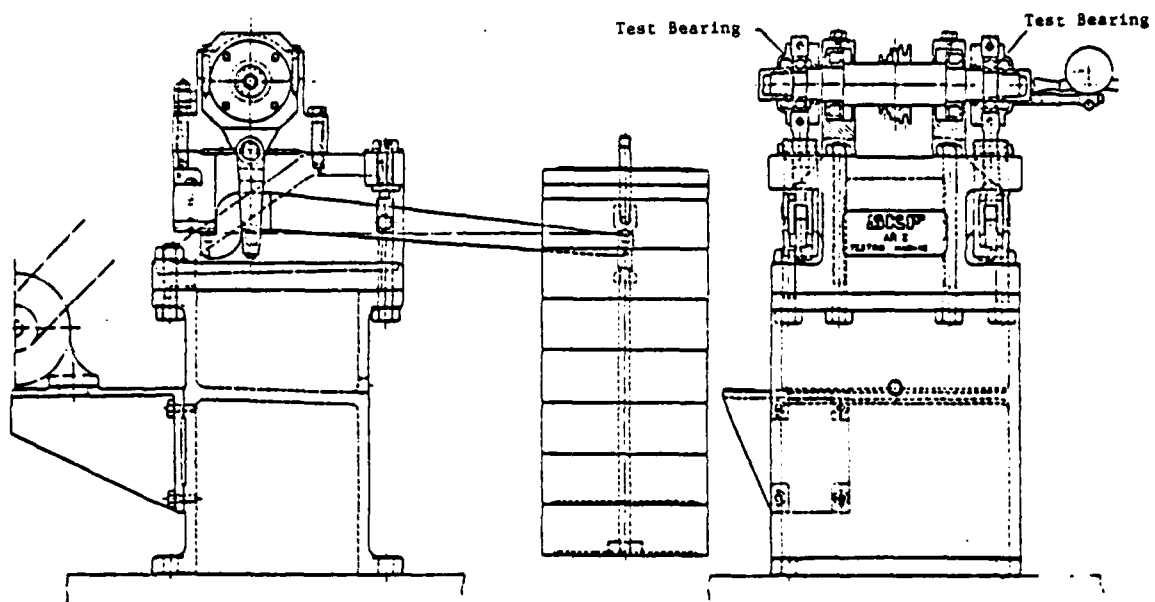
Figure 1 Layout Drawing of R2 Test Rig

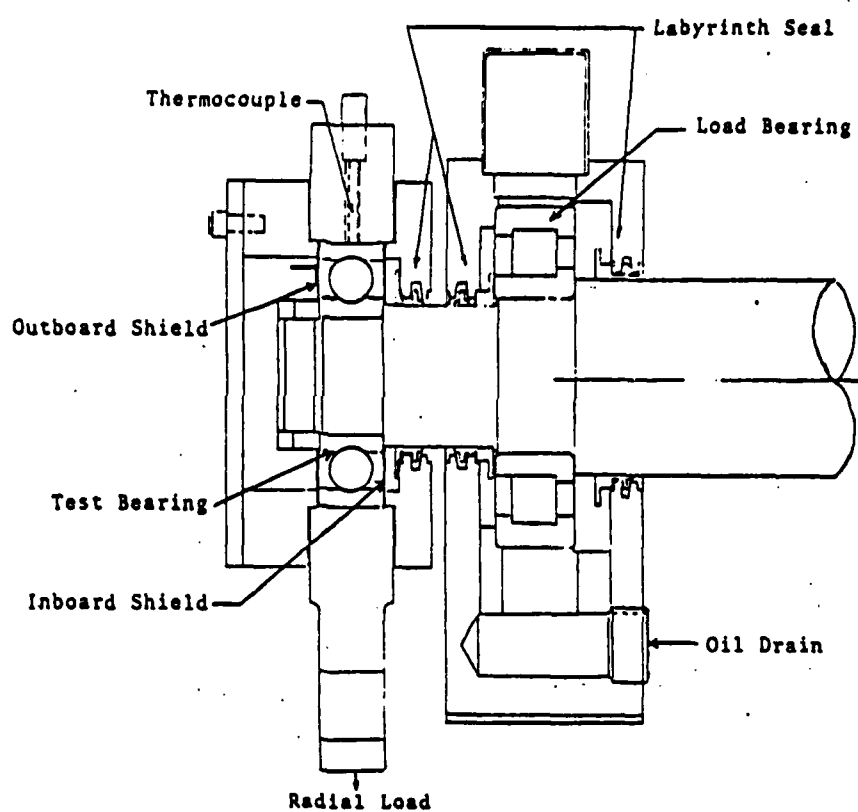
Figure 2 Detailed Drawing of R2 Test Head

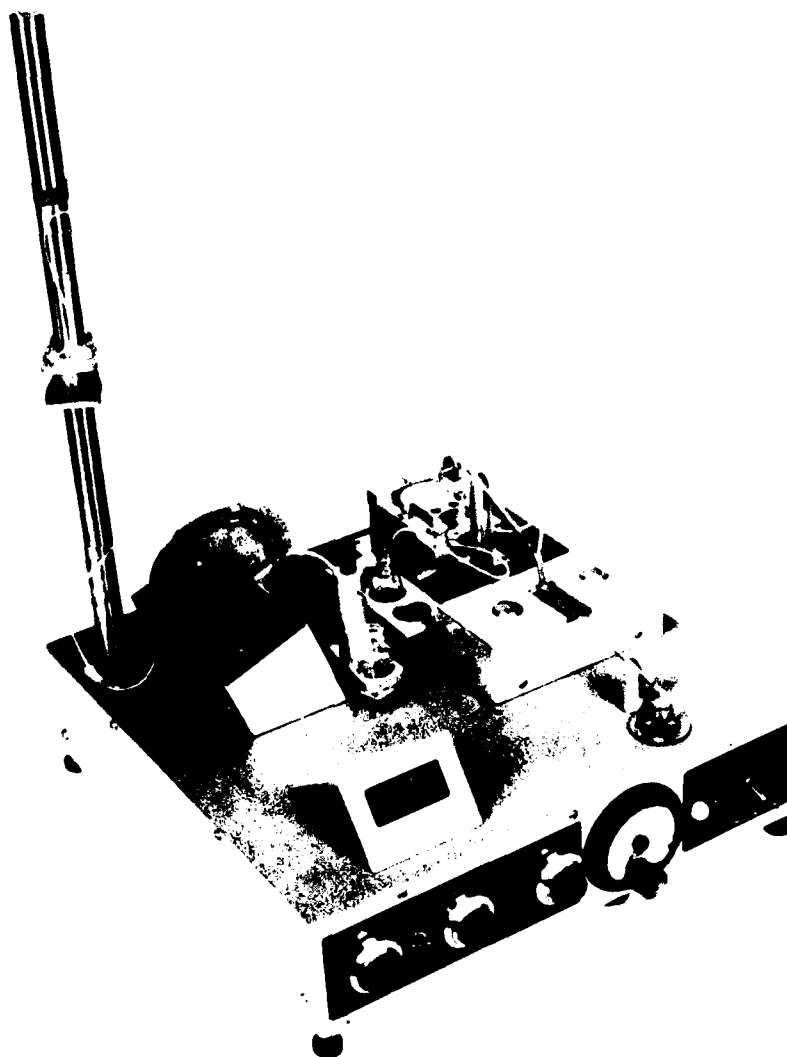
Figure 3 Duplex Ferrogram Analyzer

3. Since the analytical equipment utilized in this study has been discussed adequately elsewhere (reference(c)), a brief statement of its operation is presented here. Figures 3 and 4 illustrate the subject equipment. The Ferrography method was utilized to assess the morphological characteristics of the retained wear debris. This technique employs a variable magnetic field to separate ferrous and hybrid wear debris from a prepared sample, and selectively arranges the particles according to size. This arrangement facilitates the determination of the morphological characteristics by microscopic examination.

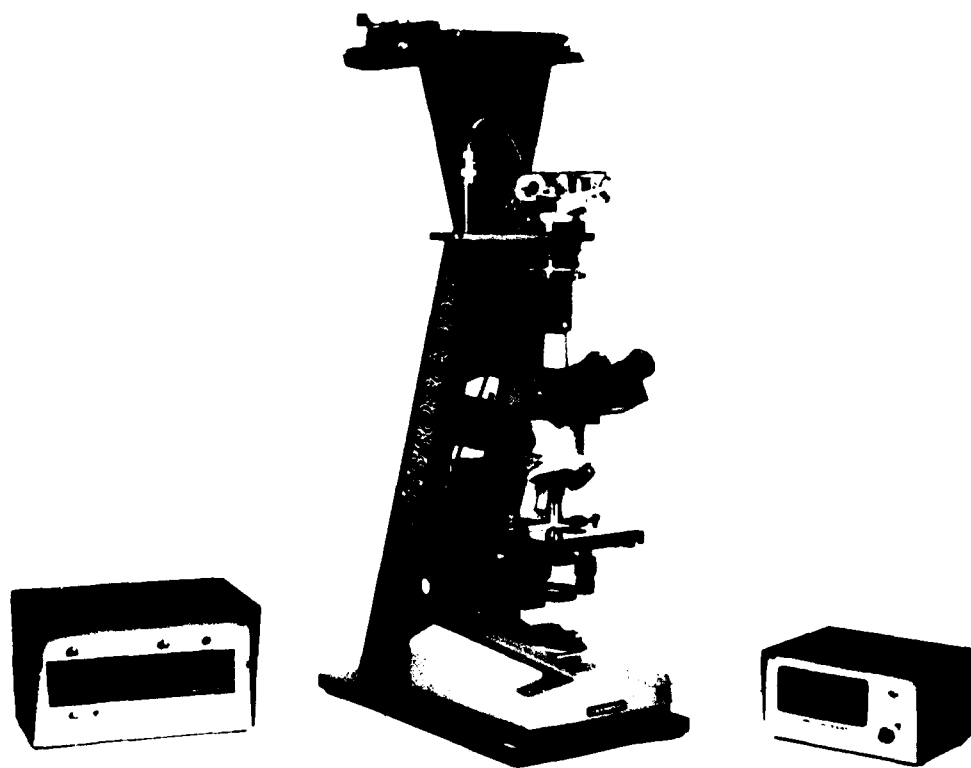
Figure 4 Ferroscope (Bichromatic Microscope)  
with Density Reader

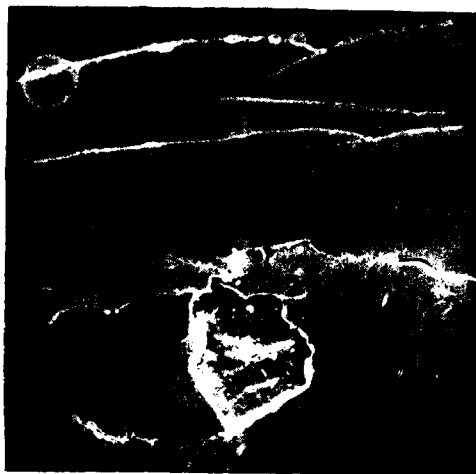
Figure 7 Spall on Inner Ring of Bearing 01

| <u>Figure</u> | <u>Title</u> | <u>Page</u> |
|---|---|---|
| 7 | Spall on Inner Ring of Bearing 01 ..... | 43 |

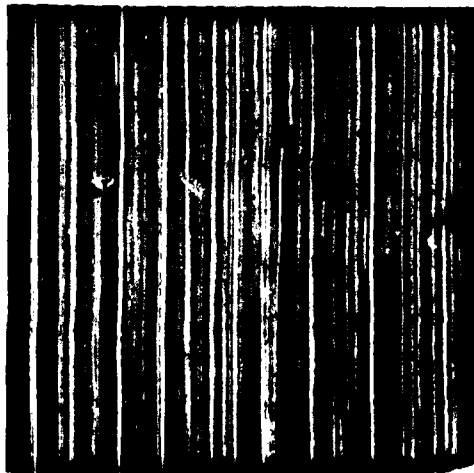
Figure 8 Photomicrograph of Original Surface  
of Bearing 01

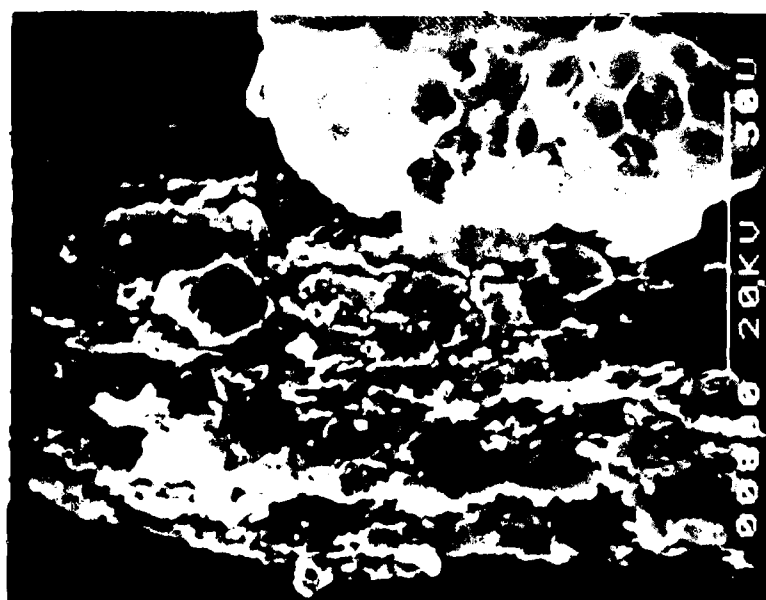
**Figure 9** Photomicrograph and SEM Photomicrograph of Ferrogram From Bearing of Case Ball Sample, After 103 Million Revolutions

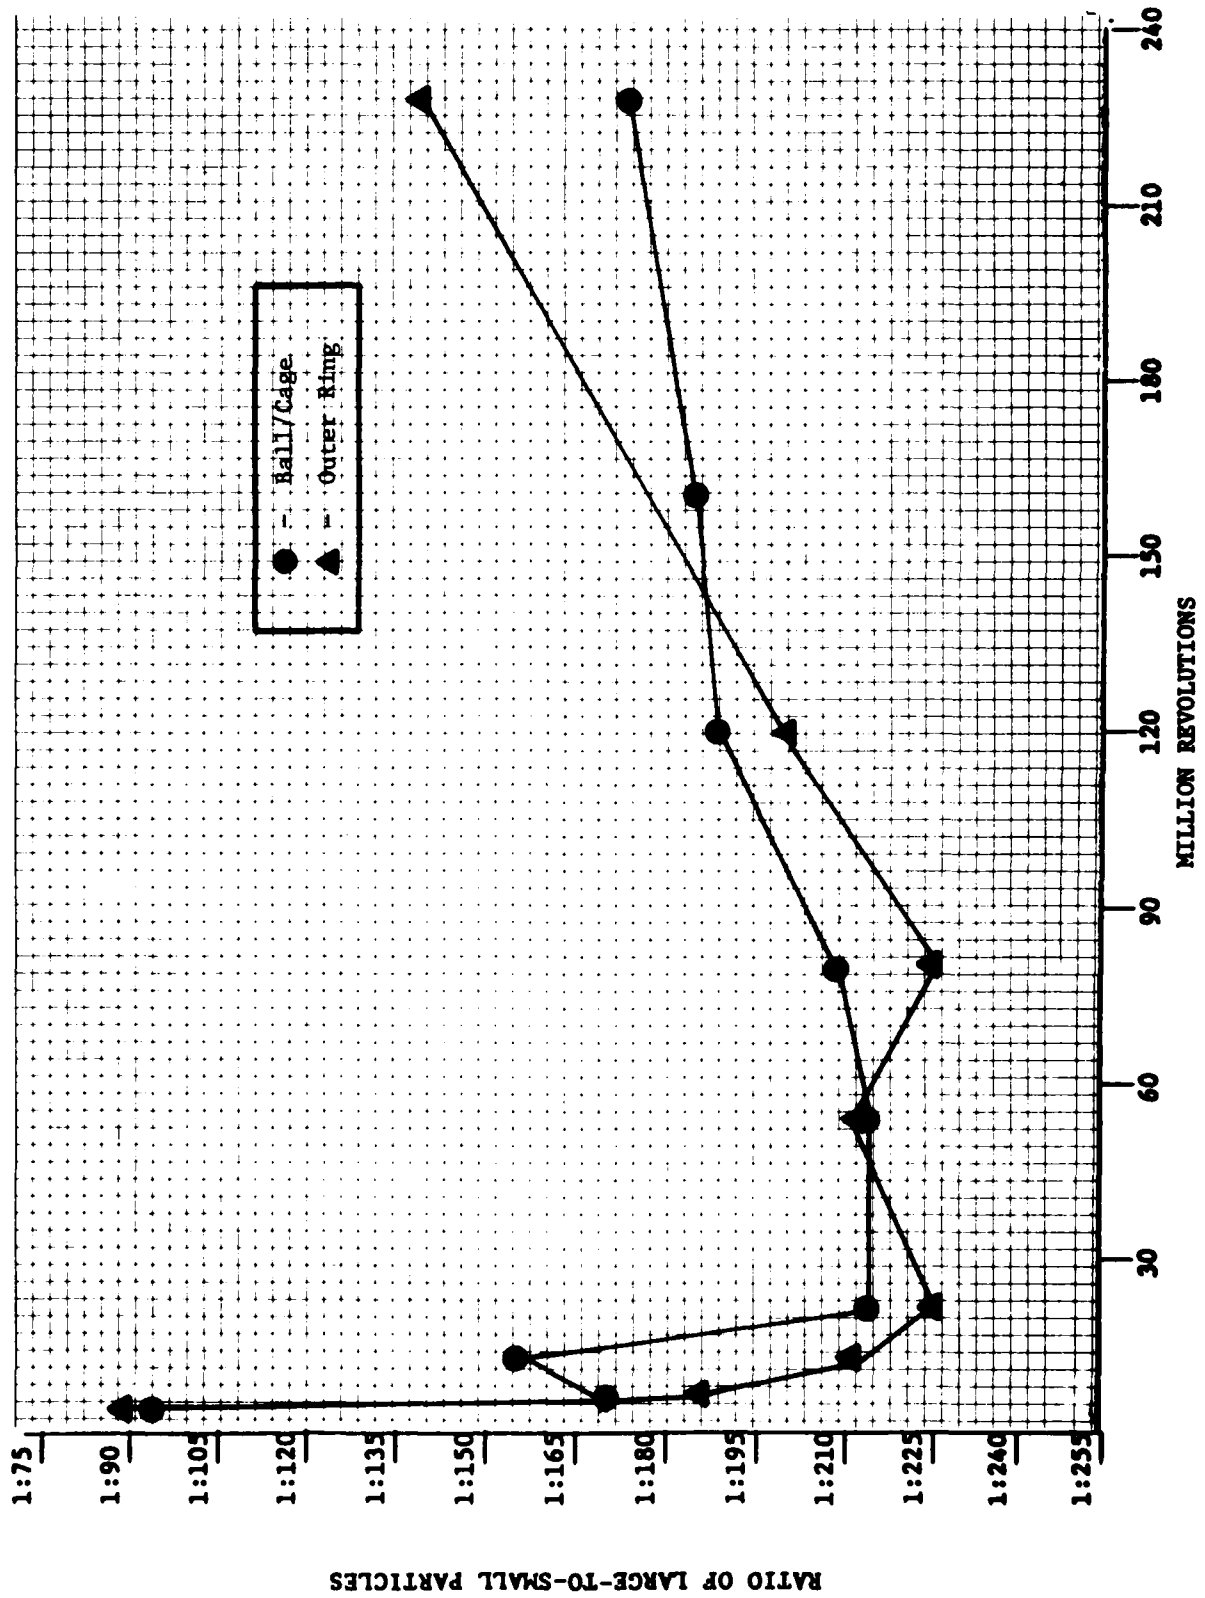
Figure 16 Ratio of Large-to-Small Particles, Bearing 03

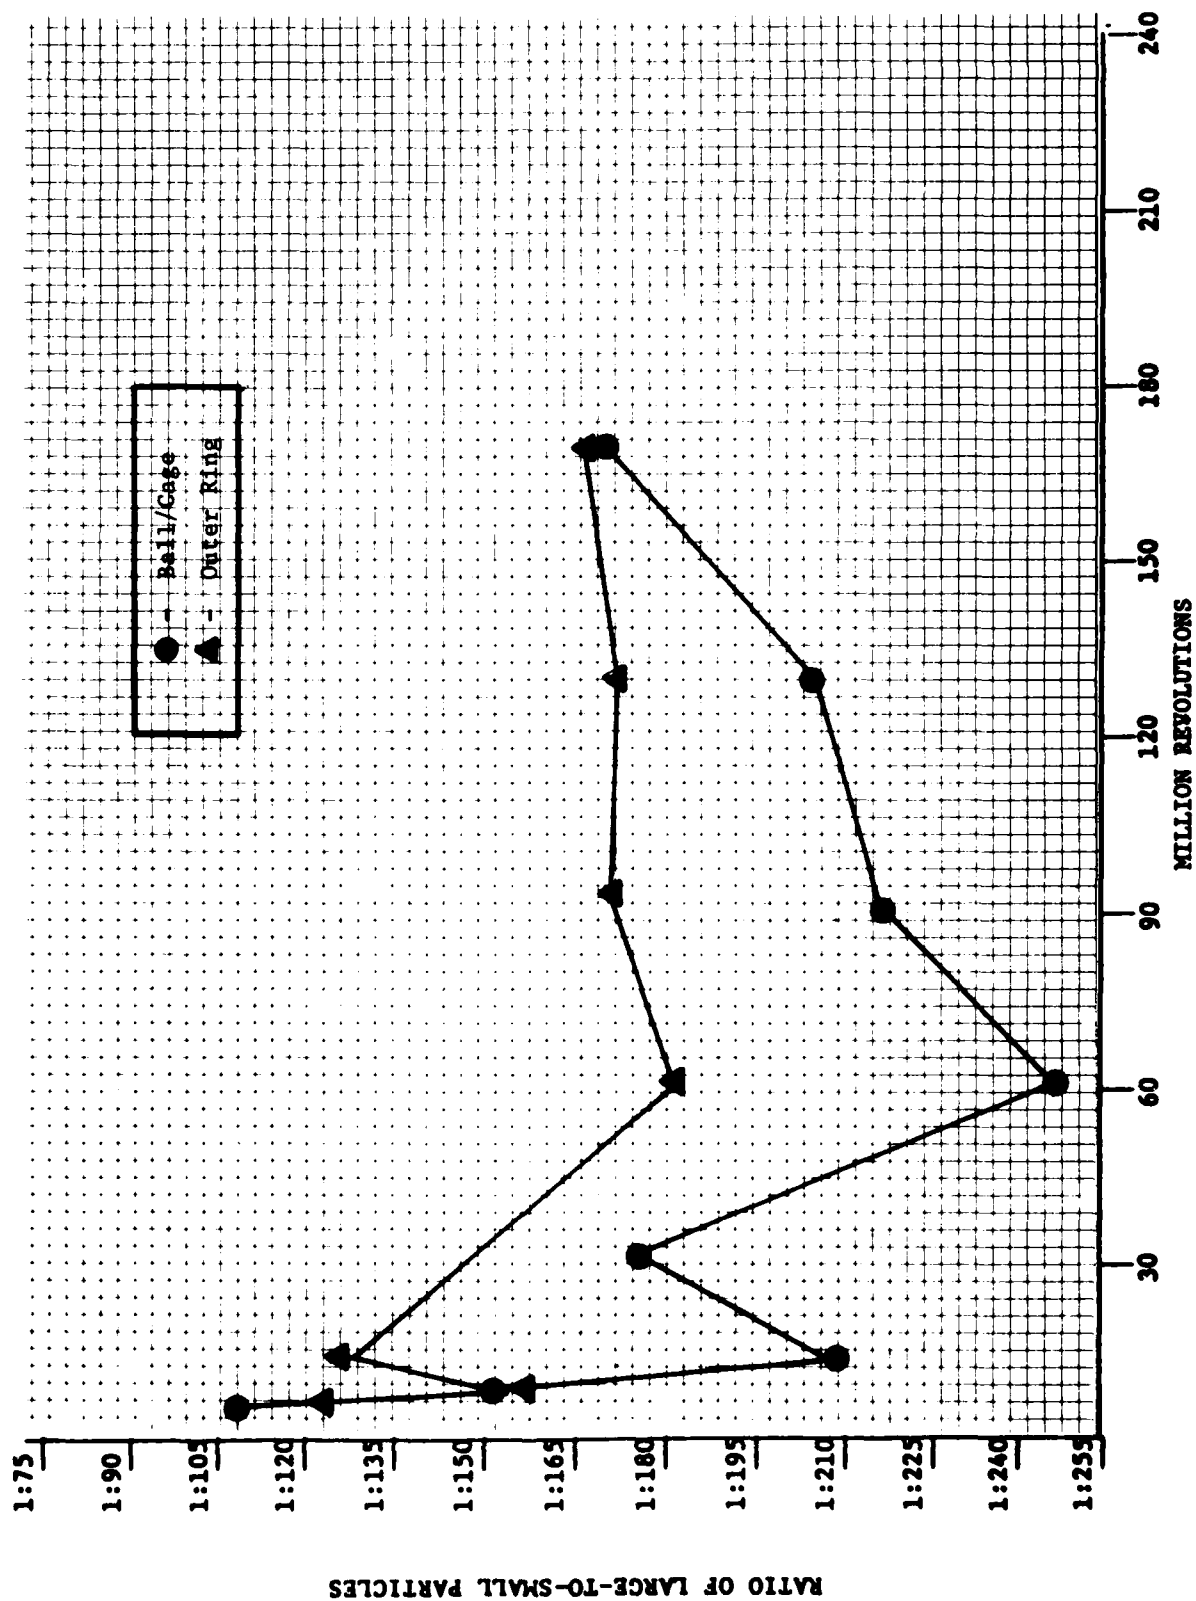
Figure 20 Ratio of Large-to-Small Particles, Bearing 04

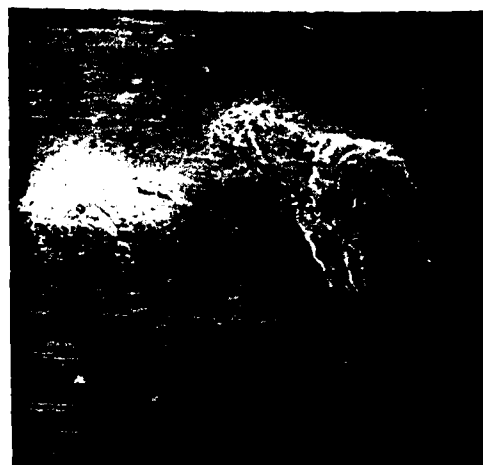
Figure 22 Photomicrographs of Bearing 05 Showing Multi-Fragment Dents  
After 20 Million Revolutions

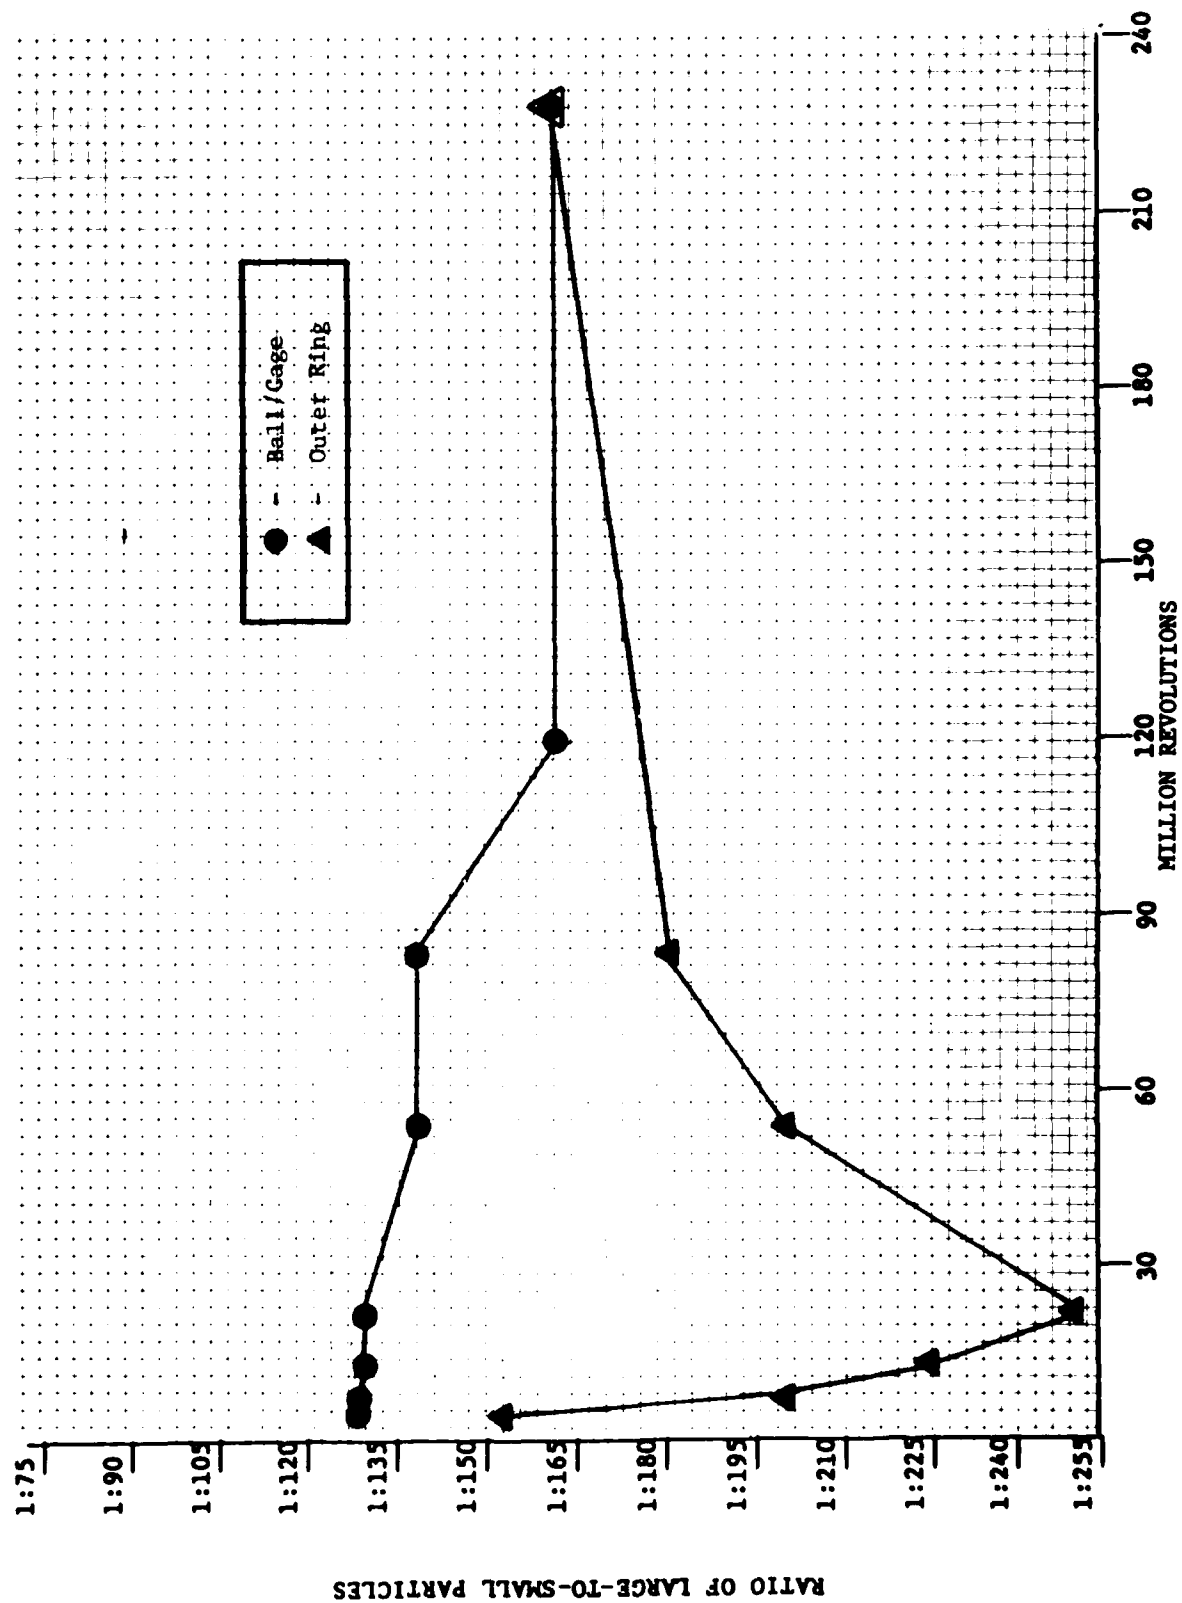
Figure 25 Ratio of Large-to-Small Particles, Bearing 05

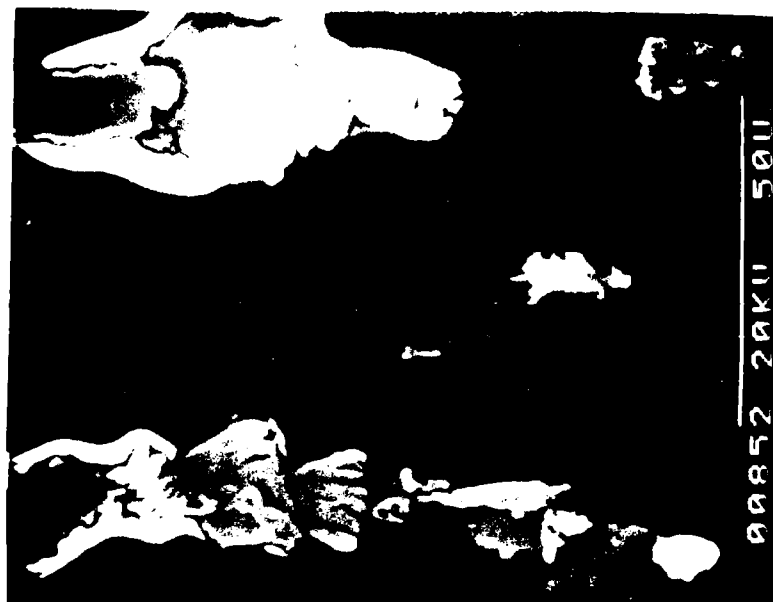
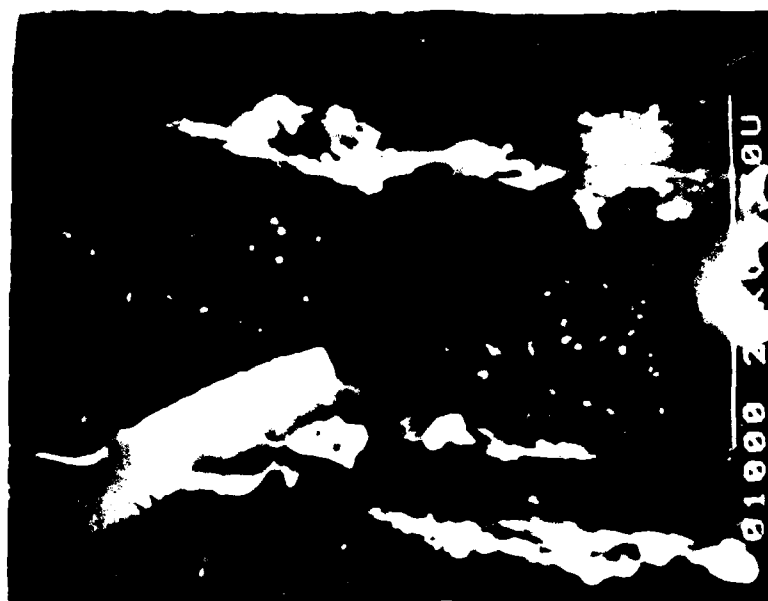
Figure 26 Photomicrographs of 400 Wt. % Tungsten Carbide Coatings from Bearing Coatings Ball 10010, After 1000000 and 5000000 Revolutions (Sheet 1 of 2)

Figure 26 SEM Photomicrograph of Ferrograms From Bearing 05  
Cage/Ball Sample, After Various Revolutions  
(Continued - Sheet 3 of 3)

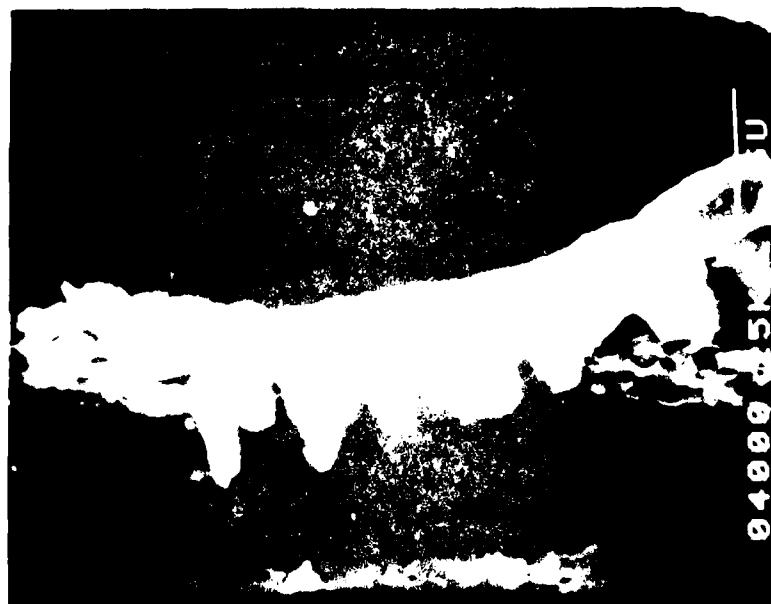
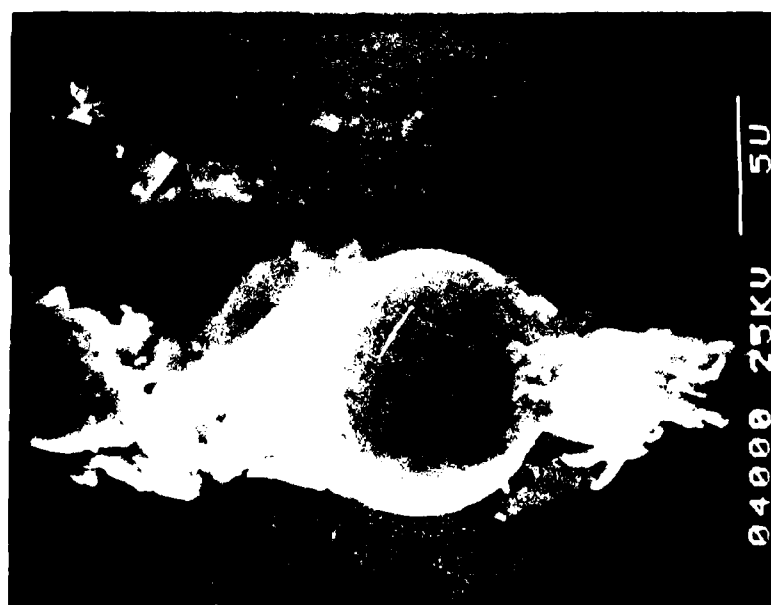
Figure 33 SEM Photomicrograph of a Ball Sample Showing Metallic and Nonmetallic Debris After 1 Million Revolutions

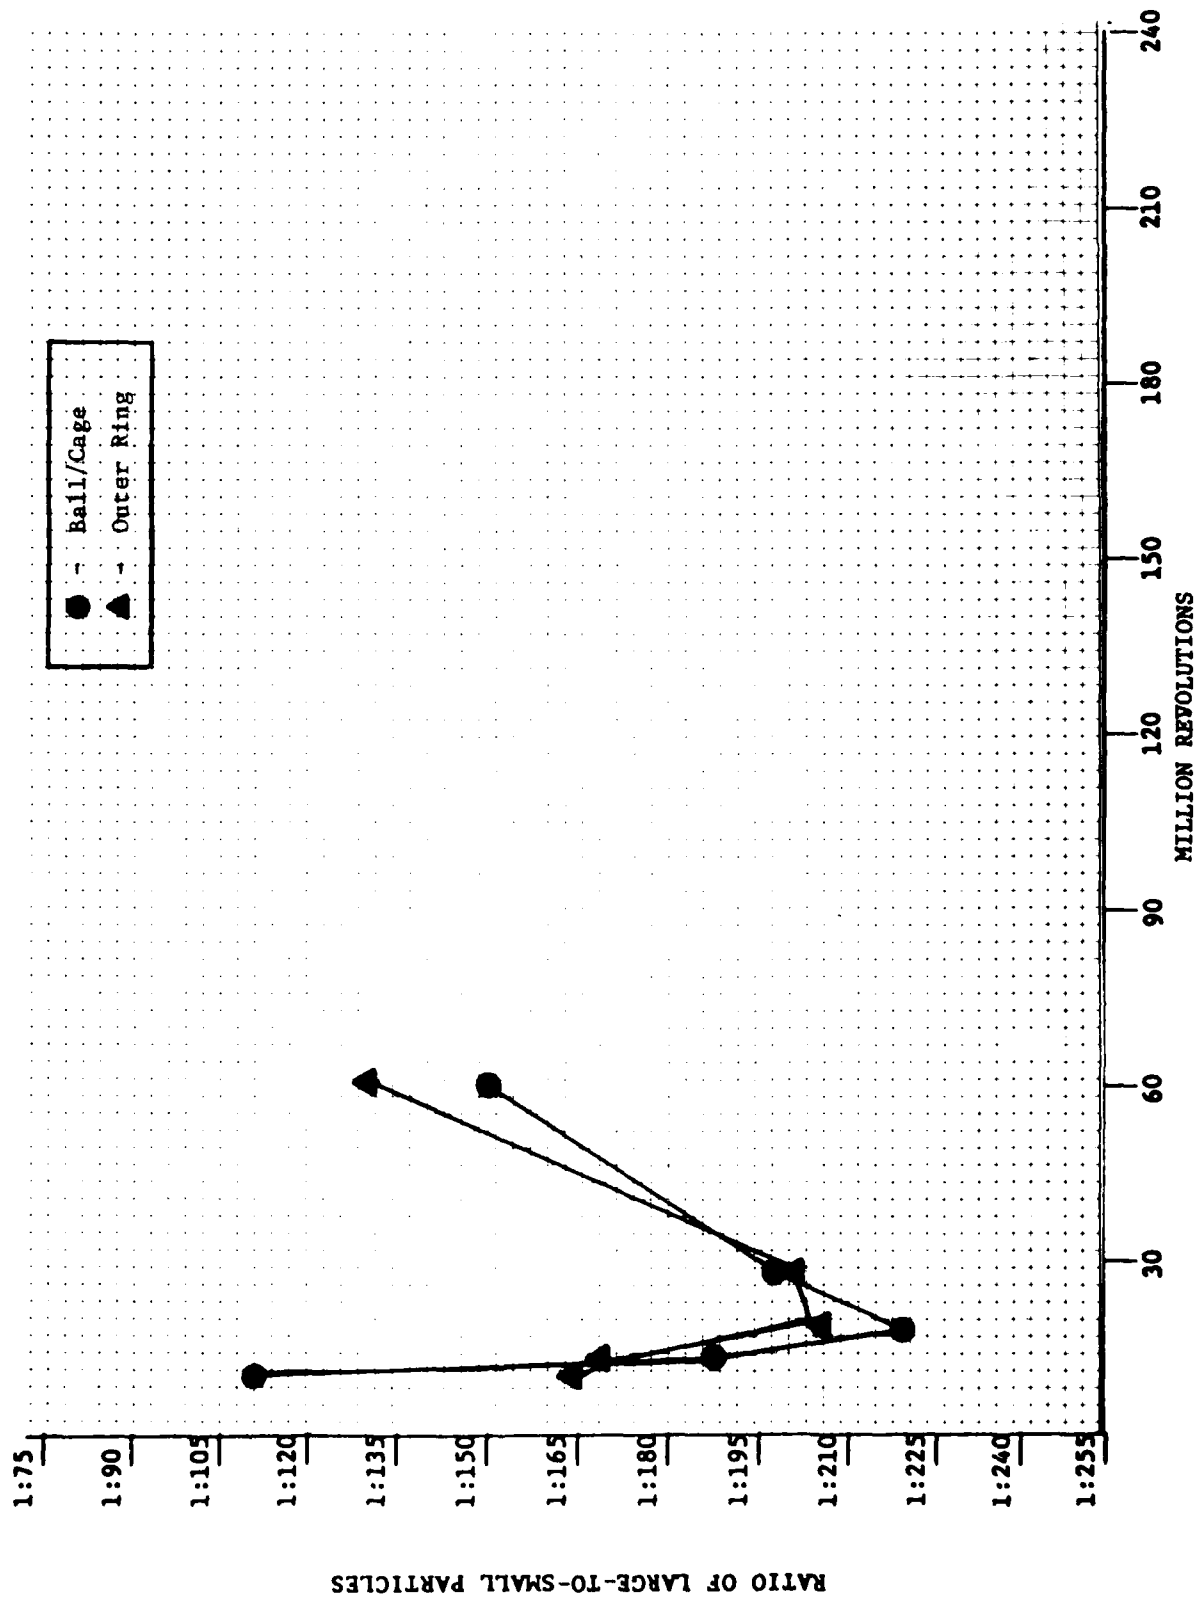
Figure 36 Ratio of Large-to-Small Particles, Bearing 06
